Manhole Inspection Summary

Manhole # S07YY1020MH

Location Address: **5813 SIMMONDS AVE**

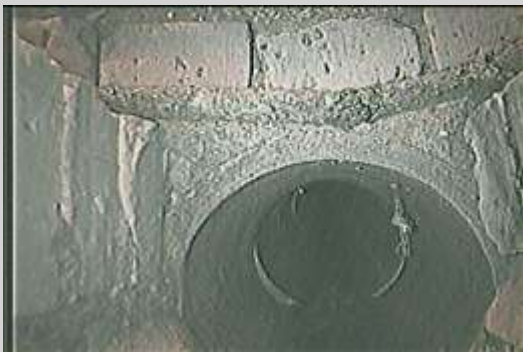
8 in. Circular Gravity Sewer Pipe Out @ 12 O'Clock

Invert Depth: **10.25** (ft.) Flow Characteristics: **Slow**

Infiltration: **None** Pipe Seal Cond: **Unknown**

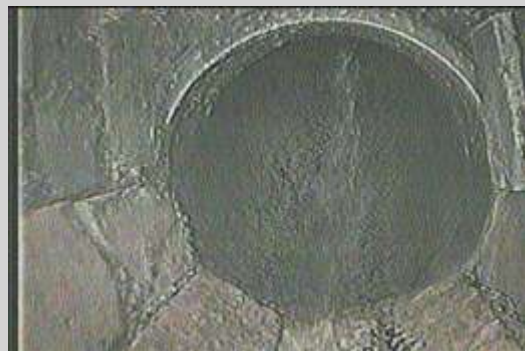
Drop In @ 6 O'Clock

Drop: **Outside** Rod and Bar

Angled: **Yes** Reading: **8.60** (ft.)

Drop Condition: **Open**
